Manhole Inspection Summary

Manhole # S39C2_018MH

Location Address: **4040 6th Street**

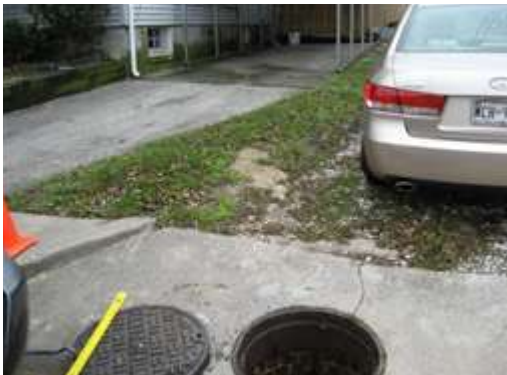
Location View

4040 6th St

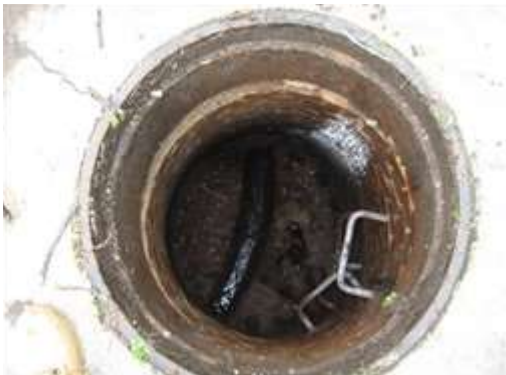
Top View

steps

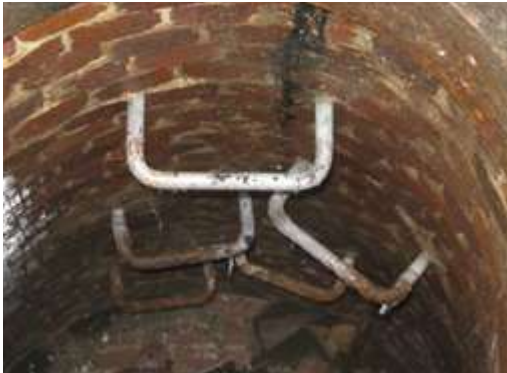
Defect 1

debris

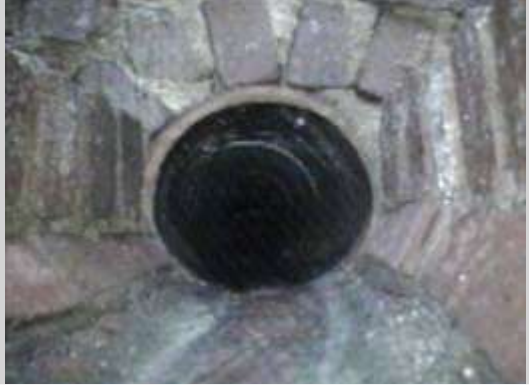
12 O'Clock Outflow

8 in. Circular Gravity Sewer
Pipe Out @ 12 O'Clock

Pipe Height: **9.6** (in.) Rod and Bar (Angled)
Pipe Material: **Clay** ☐ Pipe Lined
Invert Depth: **10.12** (ft.) Flow Characteristics: **Fast**
Deposits: ☒ None ☐ Mud ☐ Sludge ☐ Debris ☐ Grease
Silt Depth: (in.) Deposits Extent:
Infiltration: **None** Pipe Seal Cond: **Sound**

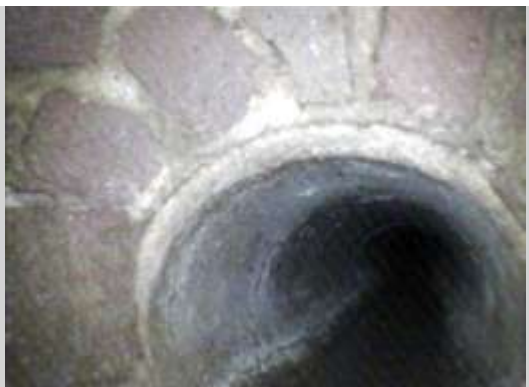
7 O'Clock Inflow

8 in. Circular Gravity Sewer
Pipe In @ 7 O'Clock

Pipe Height: **10.8** (in.) Rod and Bar (Angled)
Pipe Material: **Clay** ☐ Pipe Lined
Invert Depth: **9.94** (ft.) Flow Characteristics: **Fast**
Deposits: ☒ None ☐ Mud ☐ Sludge ☐ Debris ☐ Grease
Silt Depth: (in.) Deposits Extent:
Infiltration: **None** Pipe Seal Cond: **Sound**
